BT27.50-P-0002-02A	Plain bearing of input shaft changed to an anti-friction bearing

TRANSMISSION 722.60# /61# /660 /662 /664 /665 /69# ## as of 1317917 as of 7.1.99, 722.62# /63# /661 /663 /666 /669 ## as of 1324240 as of 12.1.99

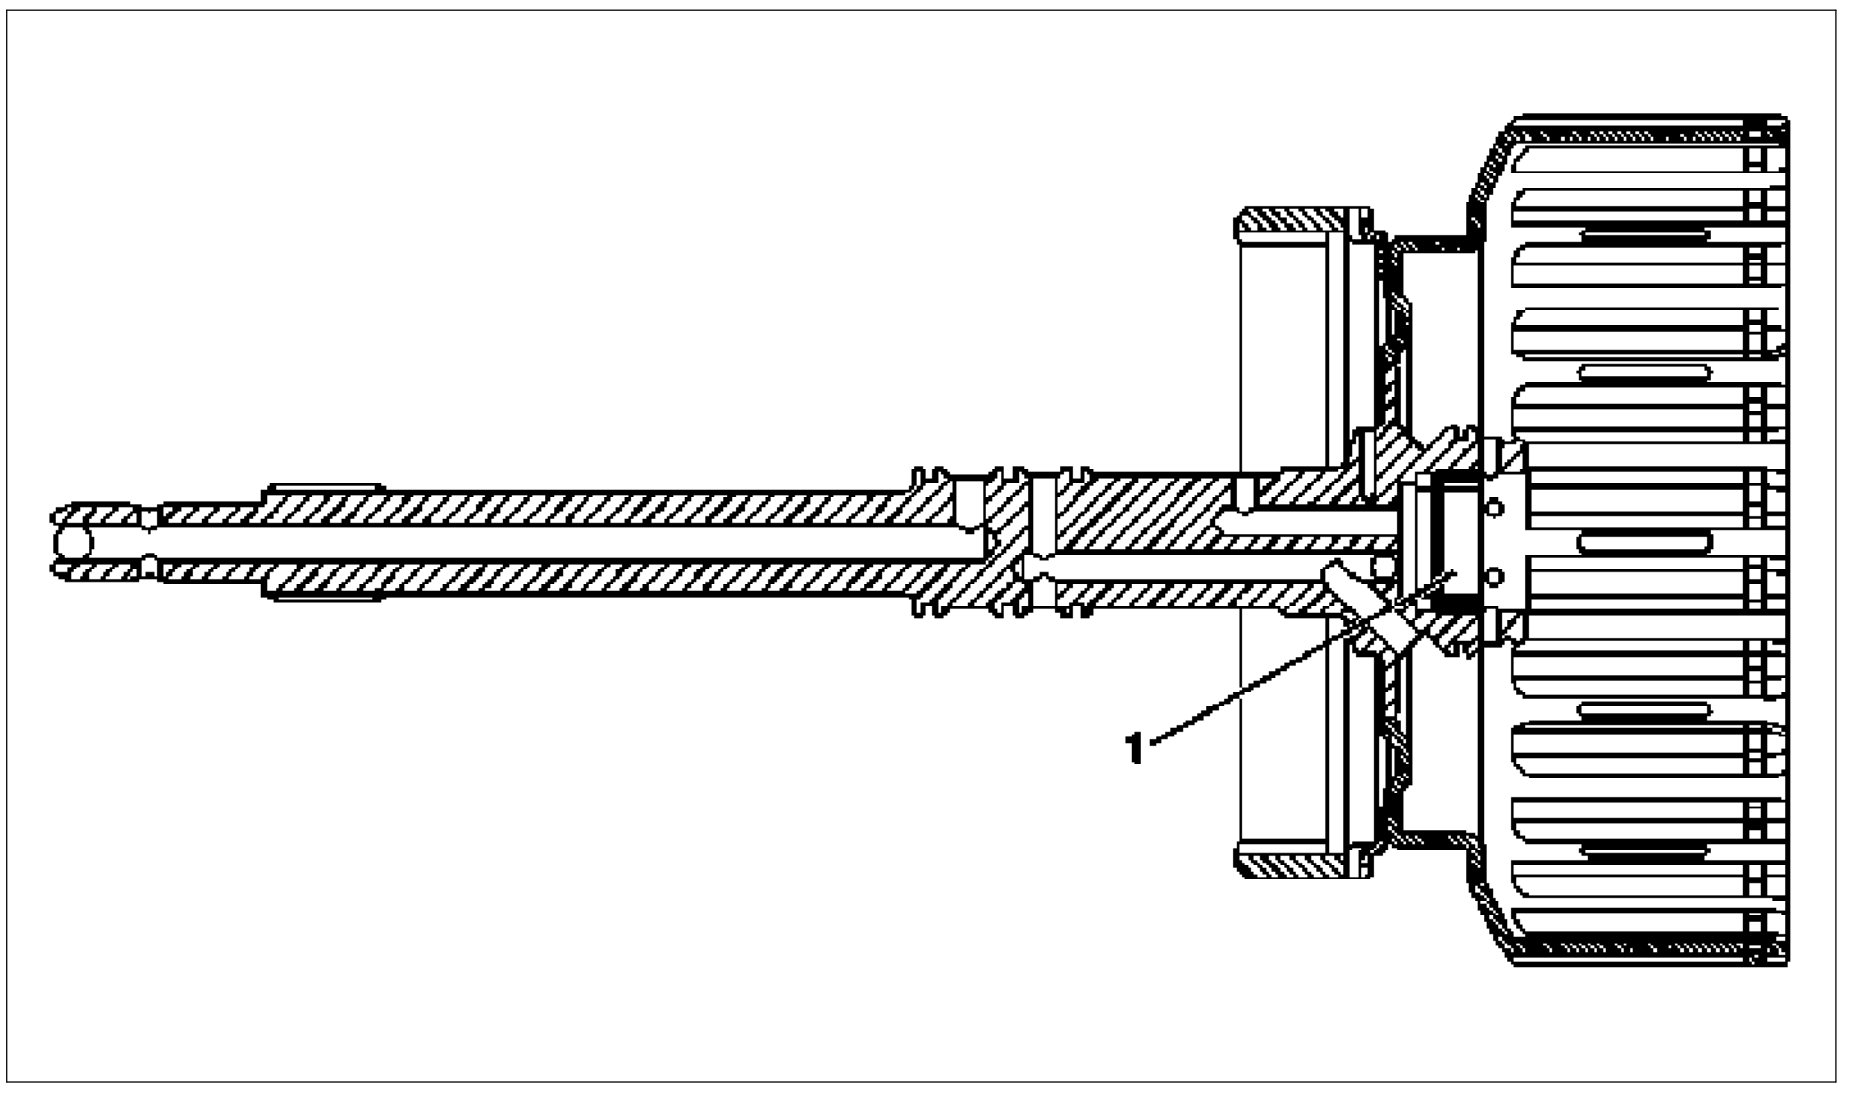
P27.51-2006-05

1 Needle bushing

The plain bearing in the input shaft was replaced by an anti-friction bearing (needle bushing).
As a result, the inside diameter of the needle bushing in the input shaft and the outside diameter of the journal at the output shaft have also changed.
When repairing a vehicle, therefore, both shafts must be replaced.
